## Service Bulletin

SB #: 005

Title: **Cracking of the Alloy Wheels**

**ALL Exodus DeltaJet 500 StingRay aircraft**

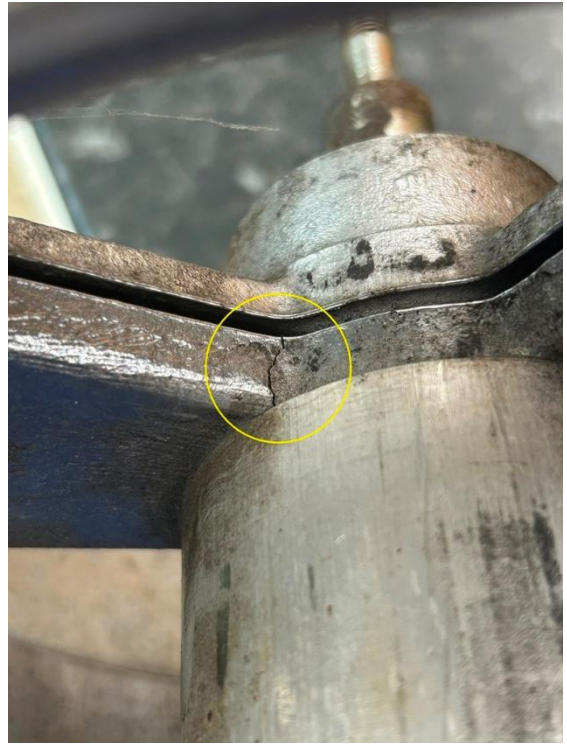
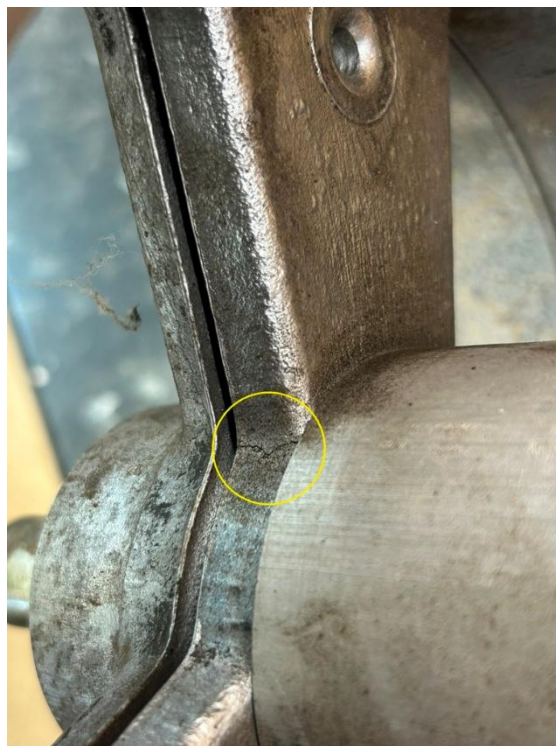
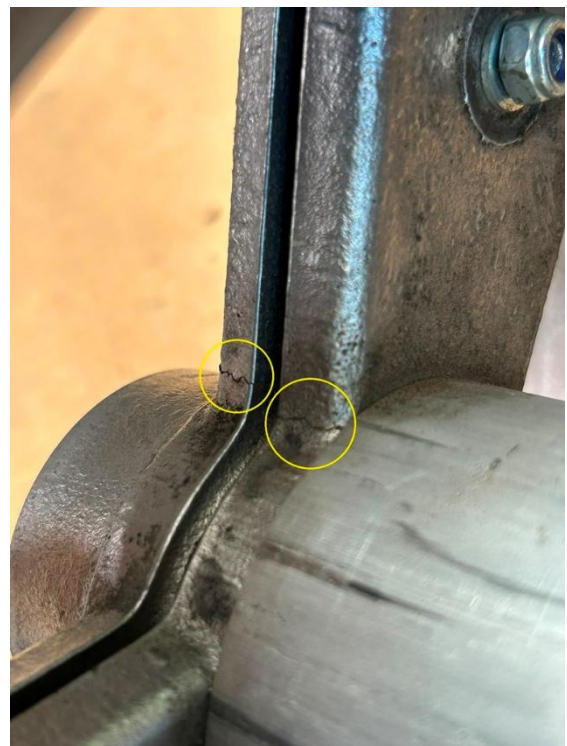
The cracks found to date have been at the base of one or more of the three spokes where they meet the axle hub. The images below show examples of what you should be looking for during the inspection. However close examination of the entire wheel should be undertaken. Whilst it is possible to inspect the wheels with the spats fitted, removing the spats allows for a closer / more detailed inspection and is therefore advised. Another option is to use a borescope to help to inspect the wheels. Dye Penetrant can also be used if a potential crack is suspected.

Note that the cracks appear to start on the spokes at the side of the wheel where the brake disc attaches but may propagate across to the other spoke.

If a crack is observed, or you are concerned about a possible fracture, do not fly the aircraft. Contact Flylight Airports or Exodus Aircraft or the BMAA immediately, preferably with images of the wheel showing the fracture feature.

**If there is any doubt, the aircraft must not be flown until a replacement wheel is fitted.**

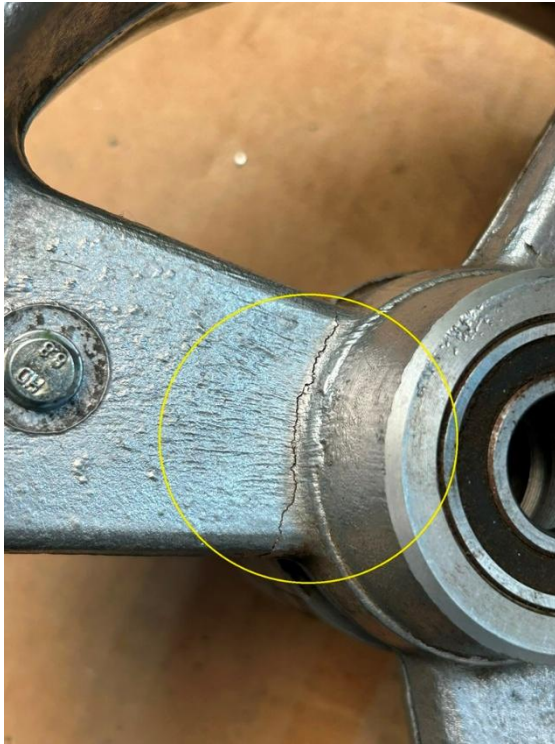
If left unchecked, the cracks will propagate across the entire width of the spoke.
